ST ETHELDREDA'S CHURCH

REPORT ON THE ORGAN

MARCH 2022

HARRISON & HARRISON LTD

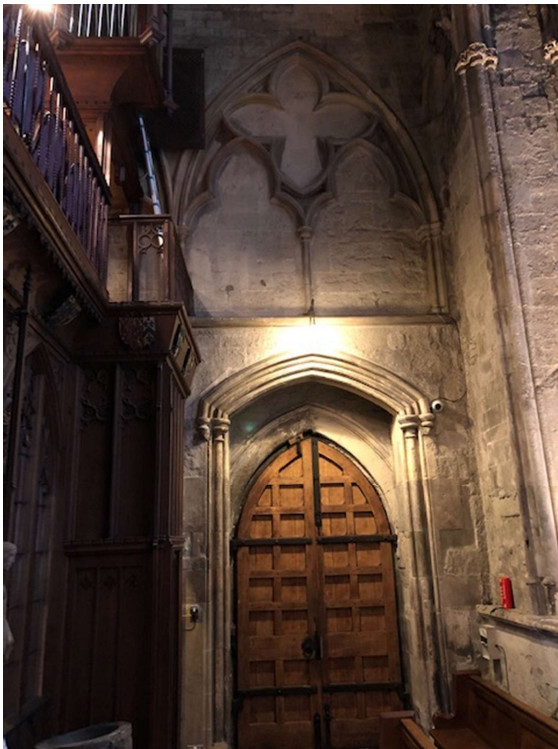
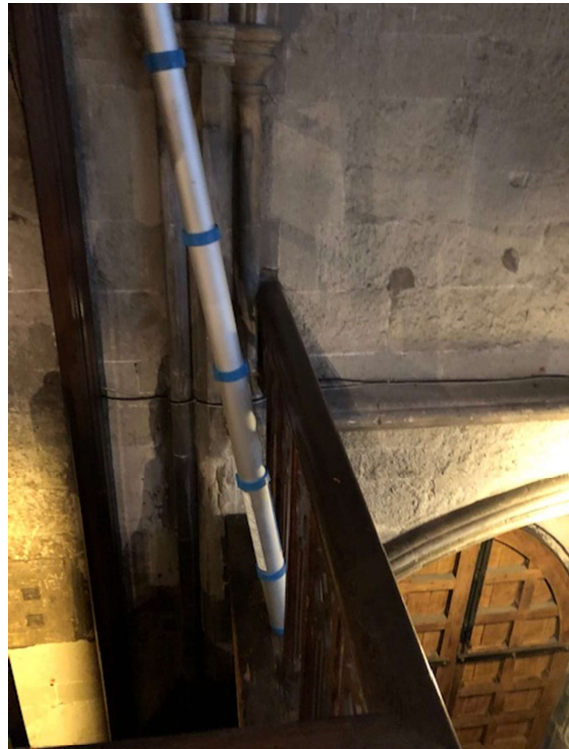
The west access to the south side of the organ. The gallery extension, height of the gallery from the floor, and the angle and method of placing a ladder over the staircase can all be seen. Ascending this ladder would effectively place the tuner over the drop to the floor

While these presumed access routes would violate Health & Safety procedures today, the same must also have been true in 2009 when the organ was designed and built.

We would not be able to ask our tuners to access the upper level of the organ due to the risks, and would imagine that the same applies to the present tuners. Without access to the upper level, however, the Great and Pedal Organs cannot be tuned and maintained.

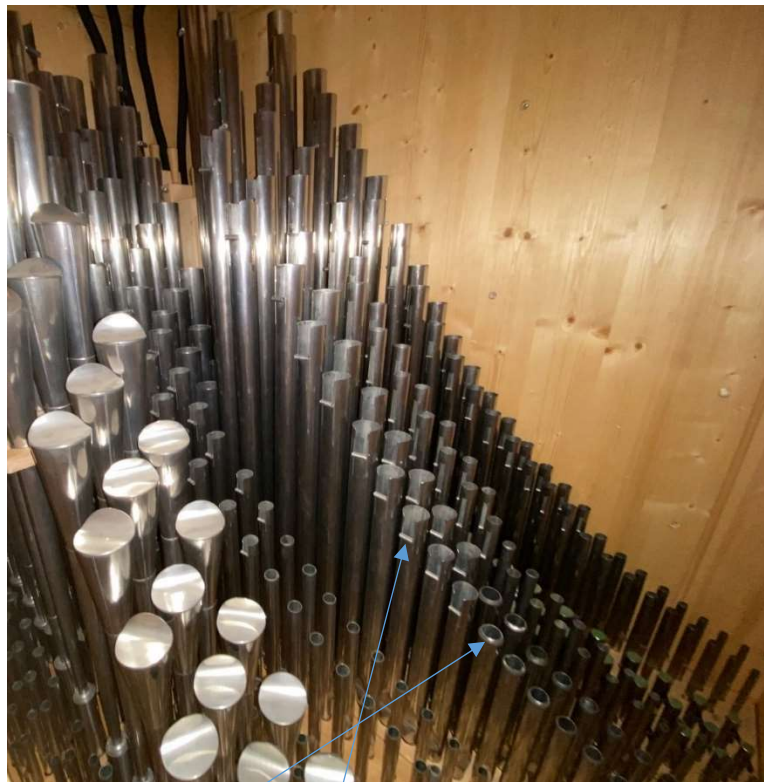
Swell pipework. Note the cone and scroll tuning and therefore the absence of tuning slides

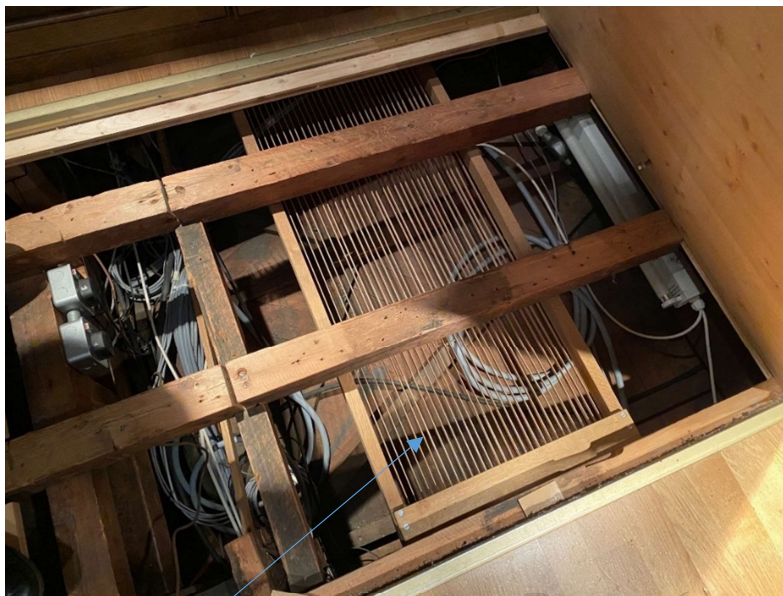
The mechanical key action of the instrument is simple and works well, though the tracker runs to the Pedal organ are longer than ideal due to the logistics of the space, with the two cases being necessarily placed against opposite walls of the church. While a few of the ribbon trackers which run under the choir loft floor have bent out of shape, this does not prevent them working.

Pedal trackers and electrical fittings under the gallery floor

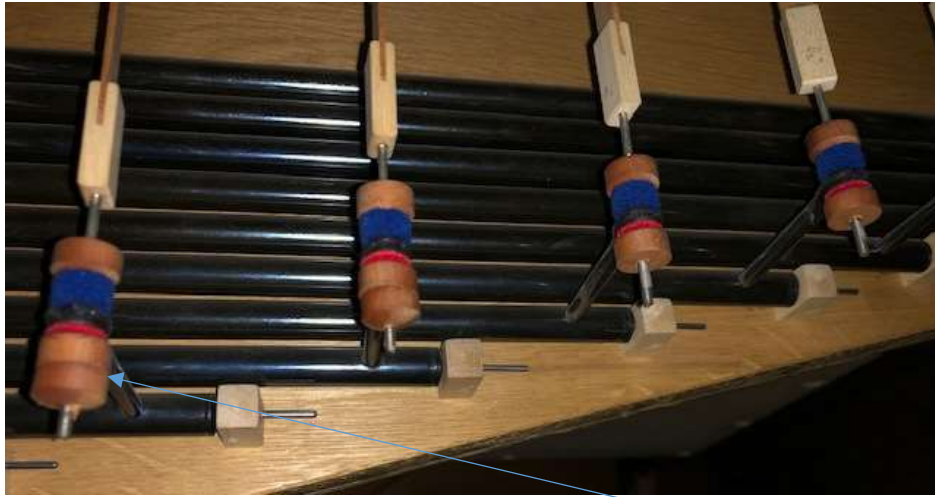
A few Pedal rollerboard actions have been fitted with double buttons, presumably to address particular problems, but we did not see the buttons stripping on the wires or the action becoming vulnerable. Overall, the action is responsive and well designed.

Pedal rollerboard with double bottom buttons

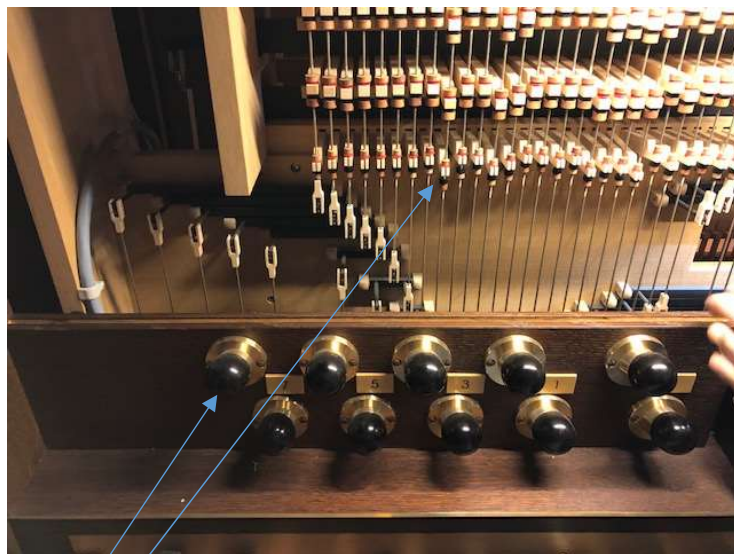
Mechanical actions of this sort should typically be adjusted every 5-10 years. Those to the manuals in particular are not in bad shape (we wonder if they may possibly have been adjusted in 2019 during the Späth visit). However, the coupler actions would benefit from regulation now that the organ has settled down in the conditions of the church. In particular, the Swell couplers through to the Great at different points in the descent of the key from note to note, and certain pedal notes on both couplers are set quite high on the action.

Pedal coupler actions showing a need for regulation. Note also the steep placement of the foot pistons, which are hidden to the player by the beam under the lower manual

- The key actions would be checked over and the coupler actions regulated throughout the organ. This is a significant and time-consuming component of the recommended work.

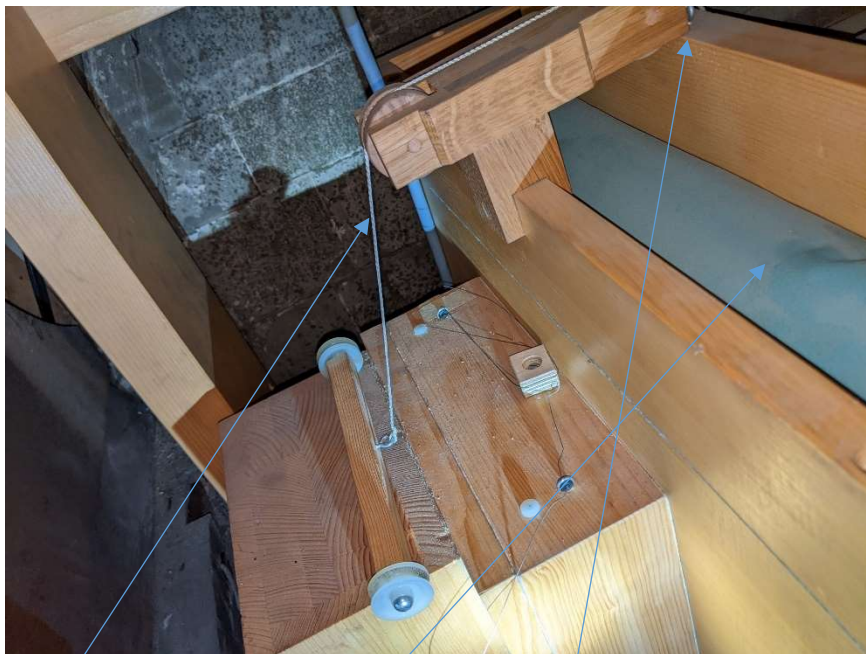
There are two blowers, one for each side of the instrument. Wind from each blower is regulated into the instrument by a roller blind, following which trunking leads to the Schwimmer and soundboard. On the Pedal side, the roller blind has failed and as a fix is currently held permanently open by a thin wire. This is not a viable permanent solution, and it does not allow air intake to respond to pipe air demand.

Pedal wind system. The roller blind is held open by the thin wire that can be seen in the middle of the photograph. The Schwimmer reservoir naturally inflates to the maximum with the rollerblind held open, so that the top part of the Schwimmer is hard against the top of the roller valve mechanism

There is a need to reinstate a permanent solution, so that the wind into the instrument can be properly adjusted and regulated according to demand, and so that the Pedal Organ

does not cease to operate when the wire eventually breaks. On test, the temporary system did not support high demand, as the Schwimmer top fell and bottomed out after only a few seconds. This may manifest as a tuning issue when the pipes are starved of wind.

- Wind noise in the bottom octave and at tenor A of the Swell soundboard would be investigated and corrected as far as possible.
- The broken roller valve to the Pedal Organ would be replaced and the rest of the mechanism reinstated and made good.

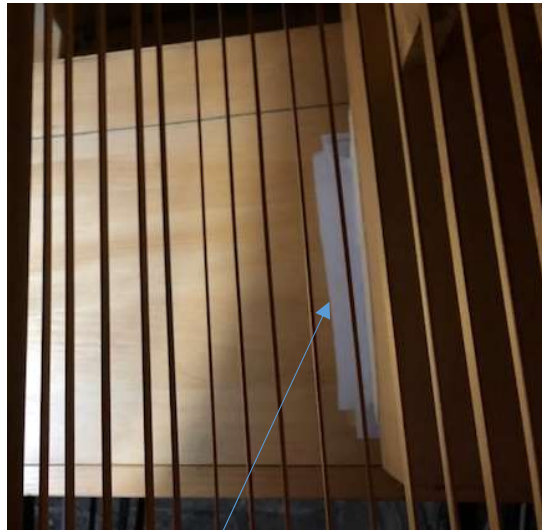
There is a mixture of wooden and copex trunking throughout the organ, typical of the style and period of its construction. This appears generally to be in good condition, though a small amount of patching has been undertaken on the Pedal side, presumably to address wind leakage.

Leather patching in the Pedal trunking

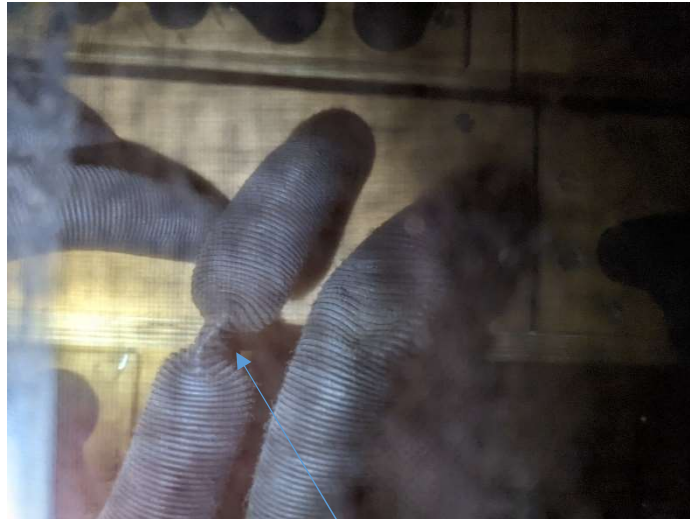
Copex is also deployed as conveyance from the soundboards to off-note pipes immediately behind the main case fronts at upper level on both sides. In several places this has been squashed, seemingly as an easy way to constrict wind intake to certain bass pipes, in place of appropriate winding or voicing regulation. This situation requires further investigation, replacement of the copex, and addressing the root problem.

Example of constricted copex conveyance reducing wind supply to a pipe

- The copex conveyances to pipework in both cases would be replaced where crushed, and the pipework or winding to the pipes properly regulated.
- The Swell Tremulant would be repaired provided that adequate access is available.

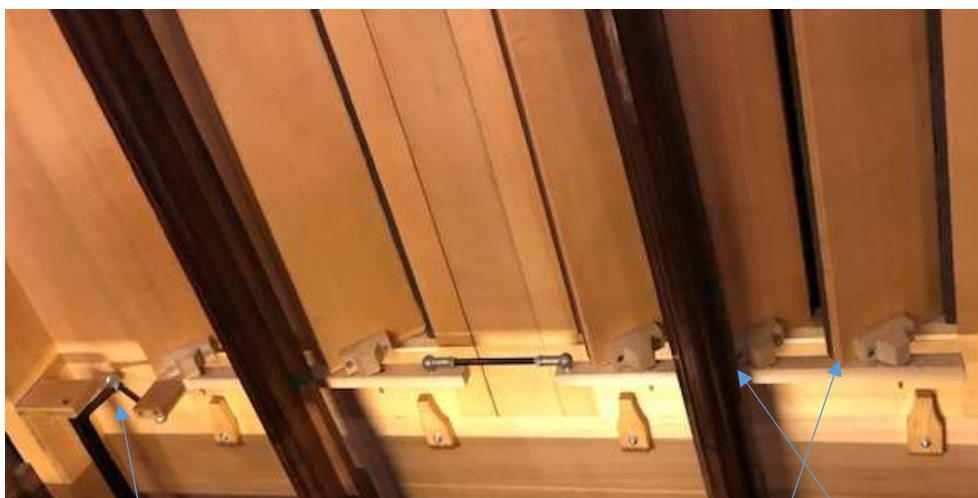
There are two shutter fronts to the east and south sides of the swell box. The swell box mechanism is poorly regulated and opening the box is not a smooth experience for the player. Various noises are associated with its opening and closing, including some at the swell pedal (see below under **Console**). The mechanism to the south-facing shutter front has little space in which to operate the shutters, the arm being set at an awkward angle to avoid conflict between the shutters and pre-existing case members, likely a casualty of the size of the instrument. This limits these shutters to 45-degree opening.

South Swell shutter front. Note the limited (45 degree) opening of the shutters and the angle of the metal mechanism operating them, as well as their proximity to the casework columns in front.

- The swell box mechanism would be improved and the associated noise significantly reduced. The easternmost shutter of the south-facing shutter front would be adjusted.
- At the console the swell pedal mechanism would be oiled and the overtravel in the mechanism adjusted as far as is possible without major dismantling.
- A suitable key cover would be provided.
- The organ would be put into a good state of tuning.

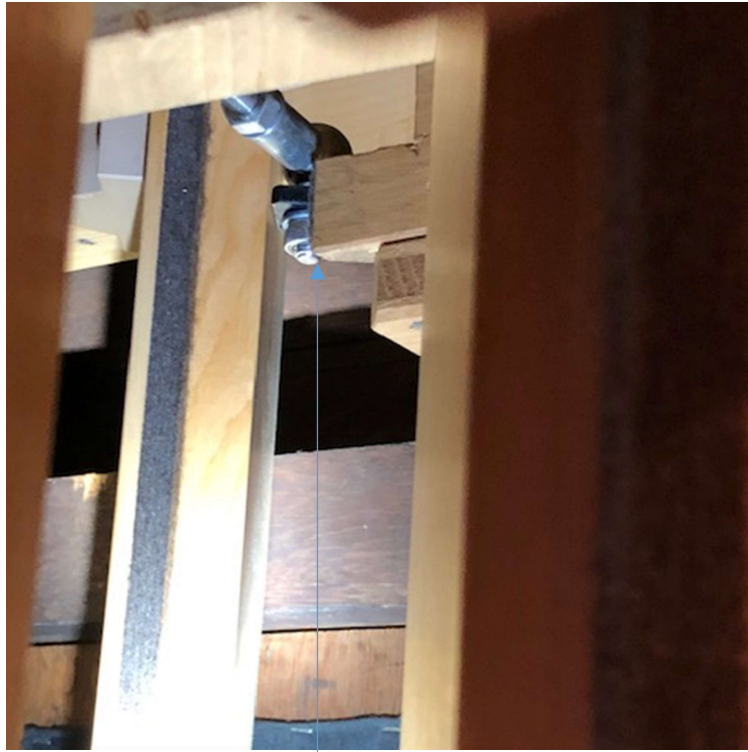
At the swell box end, part of the metal mechanism makes contact with a wooden block with a thin layer of felt as the shutters open to their maximum. Cutting the block back and applying a thicker layer of felt would reduce noise from the contact. The right-hand shutter should also be adjusted to enable it to close fully as far as possible, like its neighbours.

Wooden block with minimal felt causing banging in the Swell south shutter front mechanism. This would be shaved and a thicker felt installed to limit noise

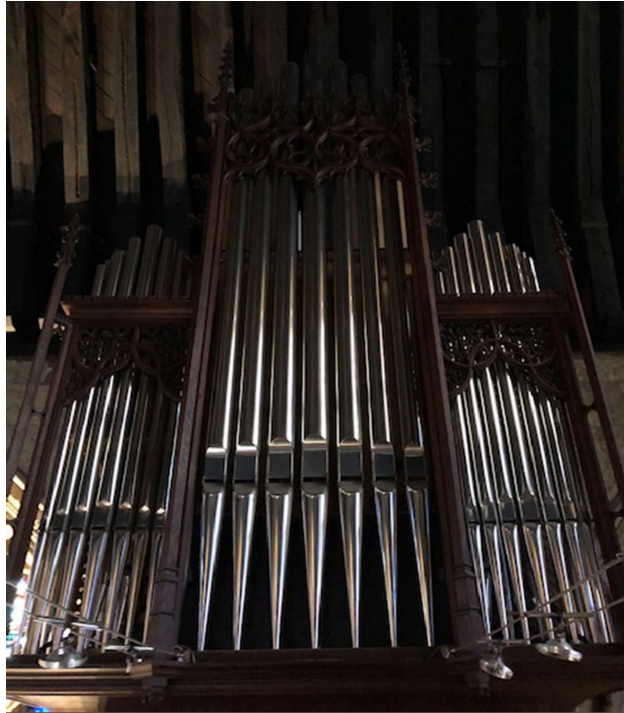
The main casework on each side looks well, with bright tin façade pipes, and the woodwork is generally in good condition. No work is required in this area.

South side case façade with new tin pipes

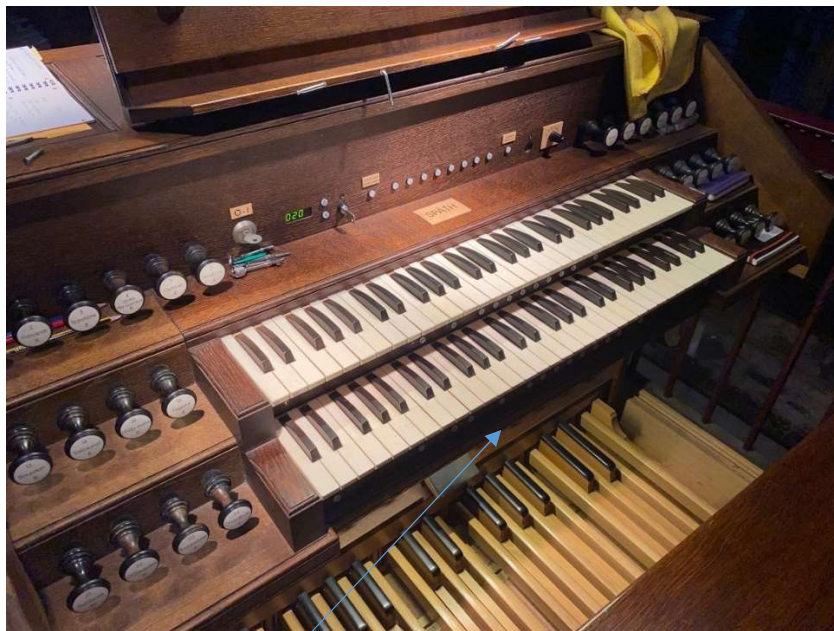
The console. The rail below the Great manual is hidden in shadow

The dimensions of the console are also not to UK standards, and the beam under the Great manual sits especially close to the player's knees and intrudes on the playing experience. This is particularly true for an organist with longer legs, and while the adjustable bench can be wound down, as it was at the time of our visit, this is not ideal for technique or posture. Care should also be taken to avoid keeping the bench permanently at its absolute lowest level (it should be wound back a small amount from this), as should there be low humidity for a sustained period the wood could split.

Alongside this main work we could undertake work to make limited alterations to the beam under the Great manual. We have costed separately for this work, which would involve dismantling part of the console.

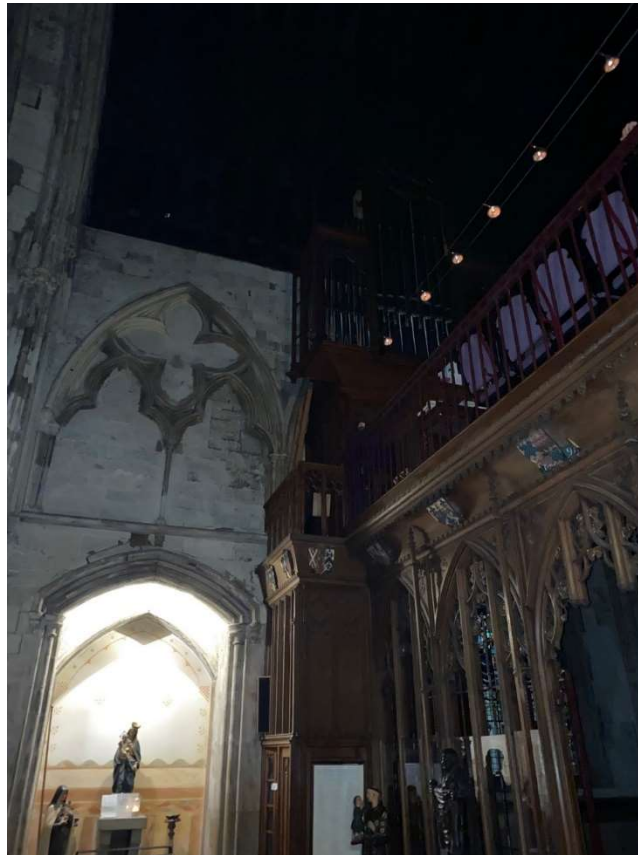
- Provision of enclosed ladder access from the floor to the north case at Great soundboard level. This would encroach on the BVM shrine and confessional access.

The BVM shrine, confessional door, west gallery extension and upper level of the organ to which access is required, on the north side
