ST ETHELDREDA'S CHURCH

REPORT ON THE ORGAN

MARCH 2022

HARRISON & HARRISON LTD

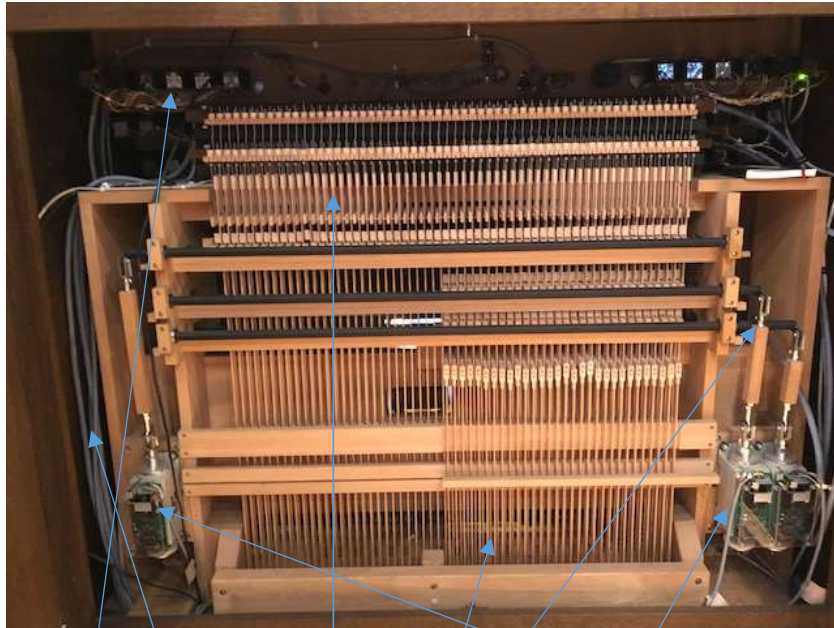
Behind the console. The manual and Pedal key and coupler actions, drawstop solenoids, wiring and robust coupler mechanisms and motors are all visible

At our visits the console was working well, and no particular mechanical problems had been reported. It has been well cared for, and the playing area is in good order.
